Case study – Onsite Laundry at a Hospital in Quebec, Canada

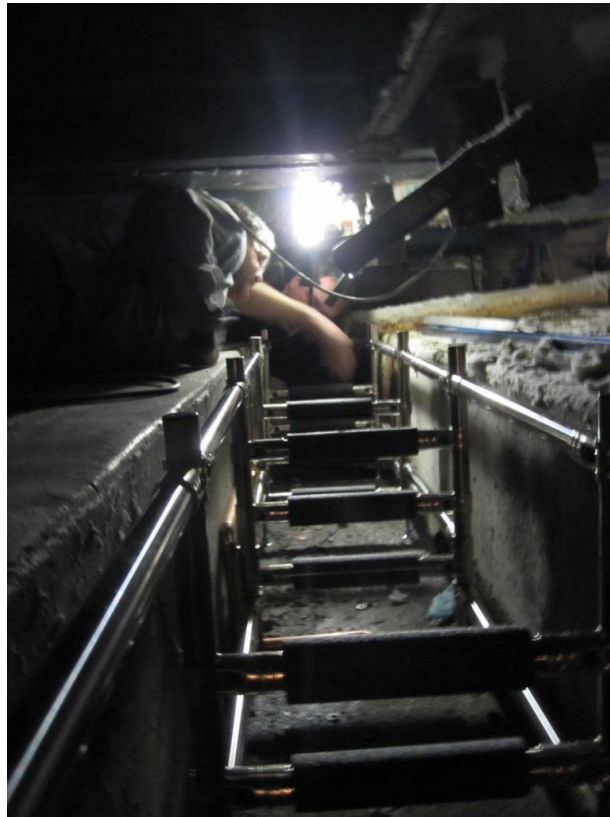
Image 1 – Installation in progress beneath the conveyor washer.

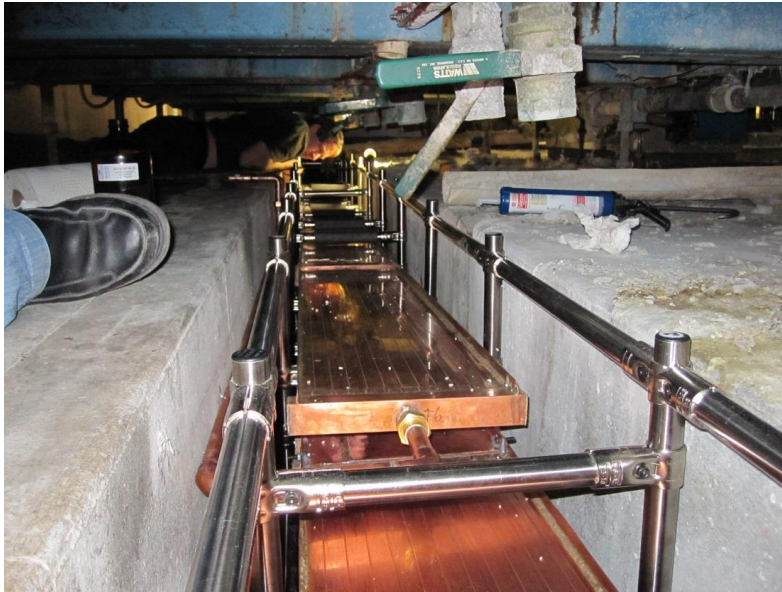
Image 2 – Ecodrain M1000 Heat transfer panels being installed beneath conveyor washer

Ecodrain proposed a modular heat exchanger system composed of panels of heat exchangers, based on the core technology of turbulators in the cold water to boost heat transfer, with the drain water flowing on top on a flat smooth surface so that the drain water and lint could easily flow over the device without clogging. Ecodrain also designed a special drain water distribution system which took the intermittent flow exiting from the drain and turned it into continuous flow over the heat exchange panels to maximize the heat transfer.

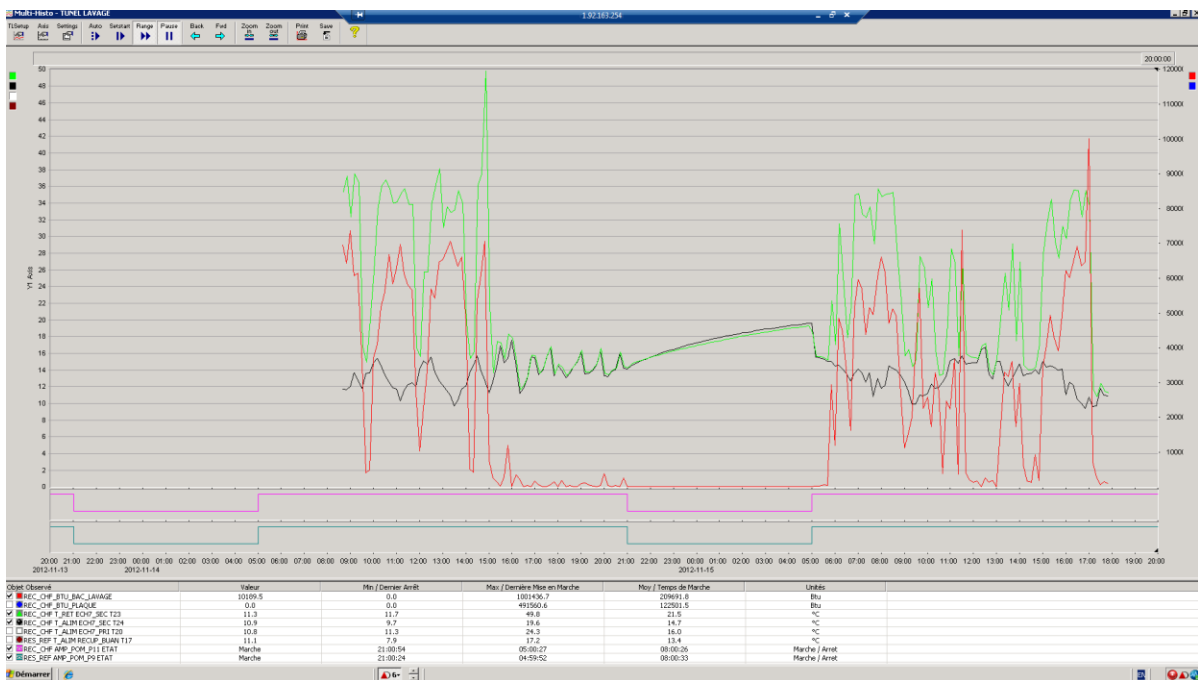
Image 3 – Real time heat trace chart indicating the substantial heat recovery (pre-heating of cold water) in the hospital laundry system, achieved by installation of the modular Ecodrain M1000 heat exchanger system.
